TOWN OF ARLINGTON  
MASSACHUSETTS 02476-4908

MEMORANDUM

RE: Intersection @ Park Ave and Route 2's Frontage Roads

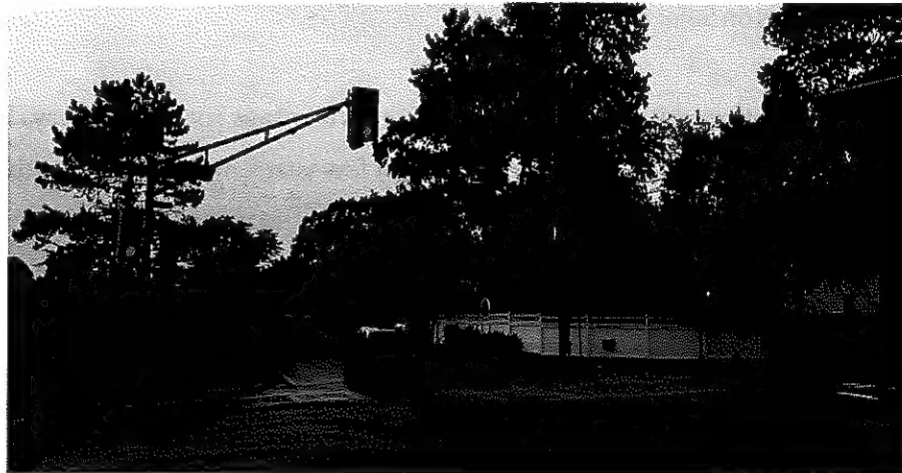
Maintenance at these signals is also infrequent. Concord Turnpike's approach on Arlington's side of the interchange has an extremely dangerous situation that could confuse a driver into thinking

they had a green light, because of a missing visor on a Park Avenue signal, as seen in the photo to the right. Furthermore, outdated "doghouse" style left turn signals currently exist at this location. MassDOT

- Perform maintenance on this signal, to check that it is up to MassDOT standards.
- Install Flashing Yellow Arrow left turn signals to replace older style 5-section signals.
  - Program a pedestrian protect phase, so that if a pedestrian clicks the crosswalk button, left turns are converted to protected only so that pedestrians can cross in a safer manner. (See image on right)
